BUILDING INSPECTION REPORT

Douglas Snow Aquatic Centre

CITY OF TORONTO - EDCT DEPARTMENT

Date of Audit Oct/Nov 2001

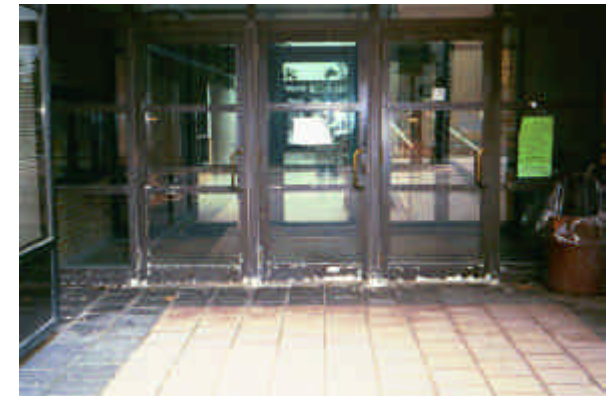
N17-P_AP3 Entrance doors

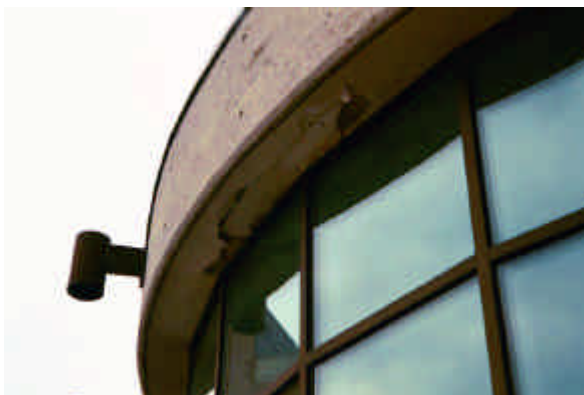
N17-P_AP4 North soffit

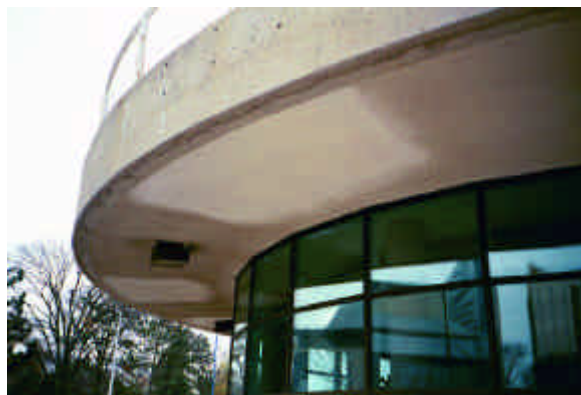
N17-P_AP5 South soffit

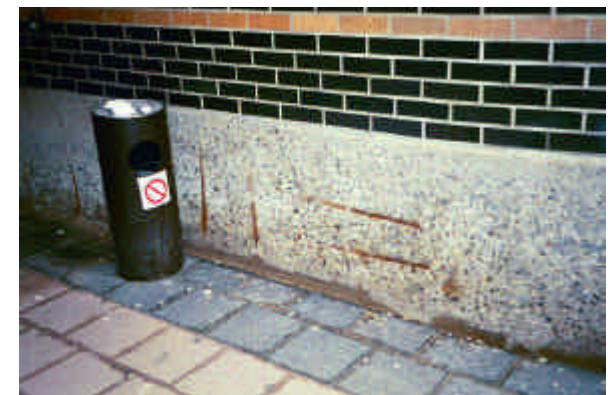
N17-P_AP6 Wall by north entrance doors

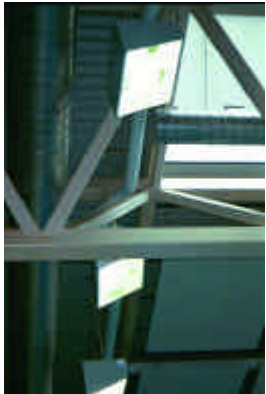
N17-P_AP7 Dirty light lenses

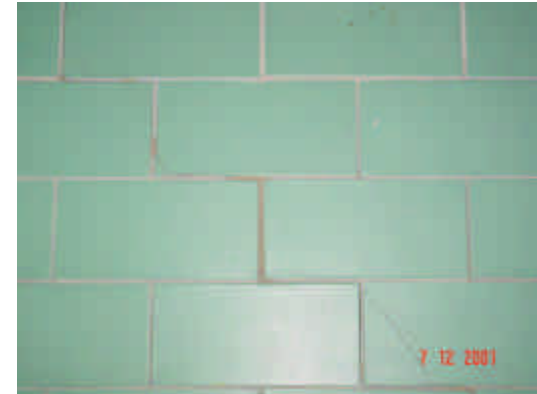
N17-P_SP2 Crack on the north-east corner block wall of pool.
