# BUILDING INSPECTION REPORT

# TORONTO PUBLIC LIBRARY

## Beaches

Address 2161 Queen Street East

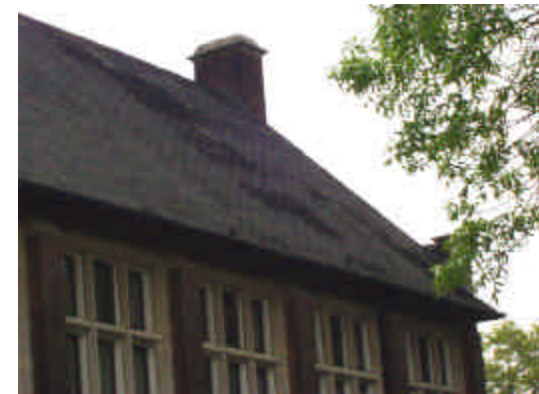
S02\_AP03 Roof shingles damaged by pigeons

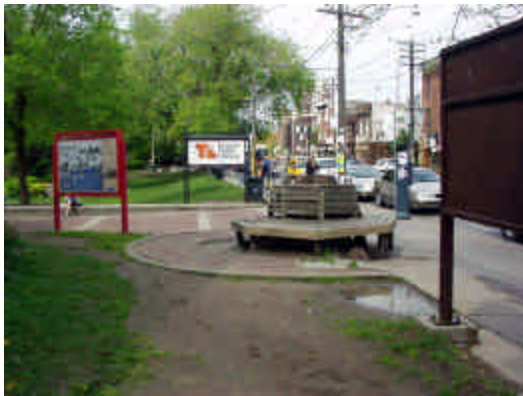
S02\_AP04 Front landscaping

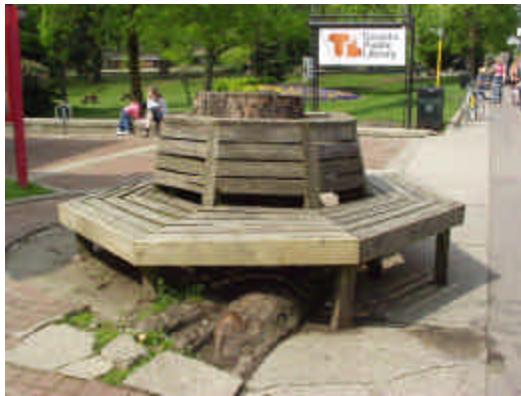
S02\_AP05 Deas tree stump and bench

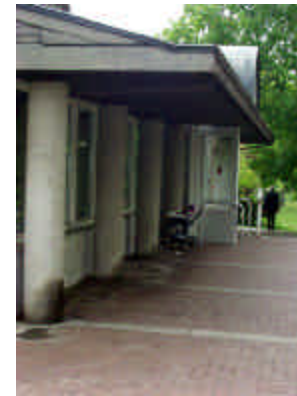
9.0 Summary	AS1			The west addition was built in 1980. The eavetroughs at the canopy are not large enough to receive heavy rain. The rain water migrates back to the building surface. The paving underneath the canopy is constantly wet, with ice build-up in winter.					
	AS2			The library is of a split -level design popular in the 70's. It is very inconvenient for the users, physically challenged, mothers with strollers, and the staff. Visual surveillance from a central control desk is impossible.					
	AS3			Inadequate washroom facilities (1 unisex and 1 HC). Additional load when the adjacent park has functions.					
	MES1			The mechanical and electrical systems in the building are in fair condition, being maintained reasonably well, but require upgrading over and above the lighting retrofit that was carried out recently, in order to provide a reasonable and cost effective working environment.

S02\_AP06 The paving underneath the canopy is constantly wet,

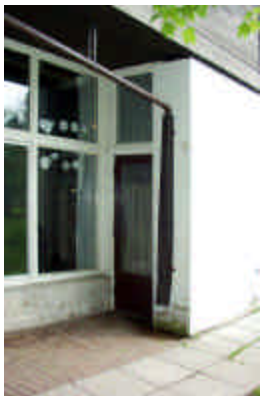
S02\_AP07 The south door, window and downspout are constantly vandalised.

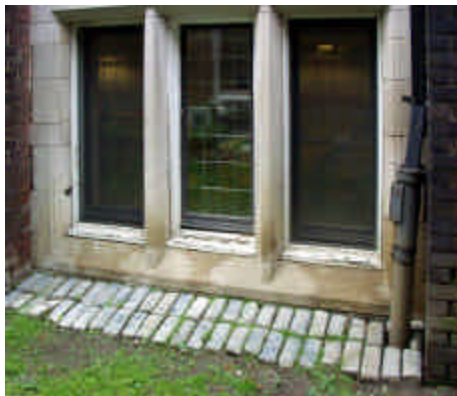
S02\_AP08 Restore/replace deteriorated stone window sills. Paint and caulk.

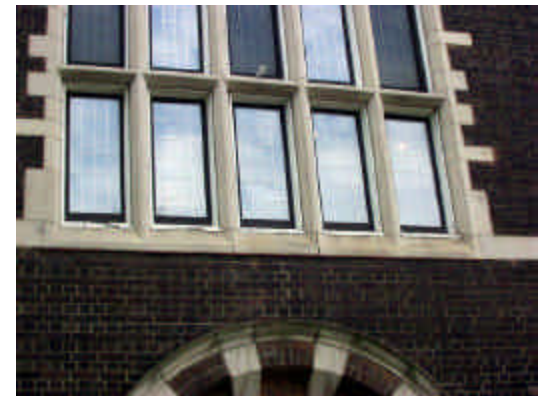
S02\_AP09 Restore/replace deteriorated stone window sills. Paint and caulk.

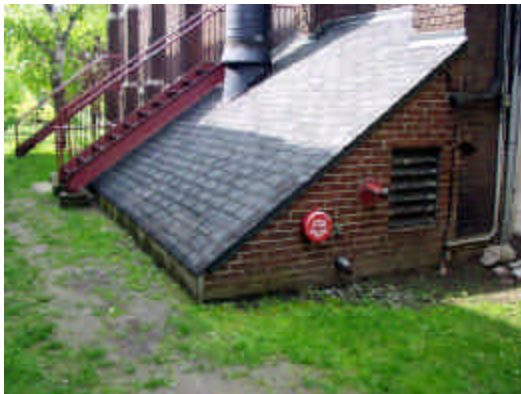
S02\_AP10 Roof above mechanical room.

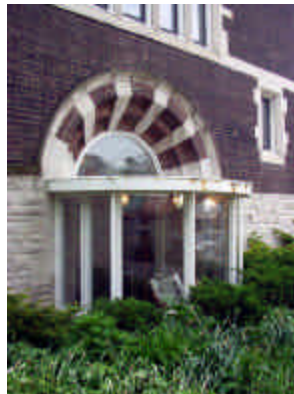
S02\_AP11 Rust on metal fascia of the semi-circular reading alcove on north side.

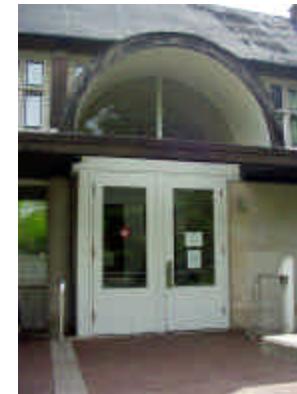
S02\_AP12 Front door should be replaced. Paint fascia.

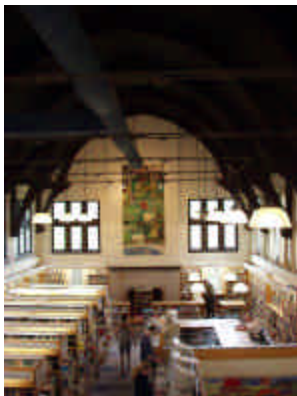
S02\_AP13 Wood ceiling

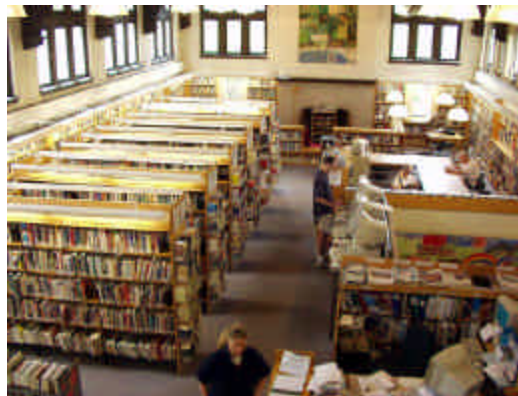
S02\_AP14 Main reading room

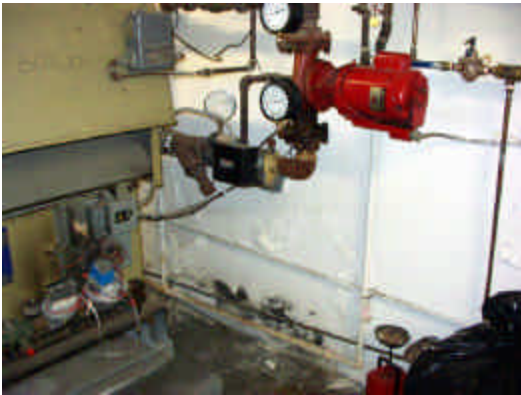
S02\_AP15 Water migration to the east foundation wall inside the Mech. Room. The walls have to be painted every 6 months. Excavate and repair weeping tile.

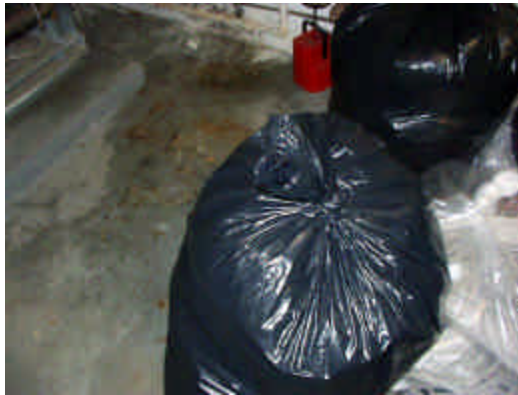
S02\_AP16 Mechanical room. Patch and paint floor.
